# Mine site : What to consider if Rehabilitation is to Occur.

DAISY SUMMERFIELD

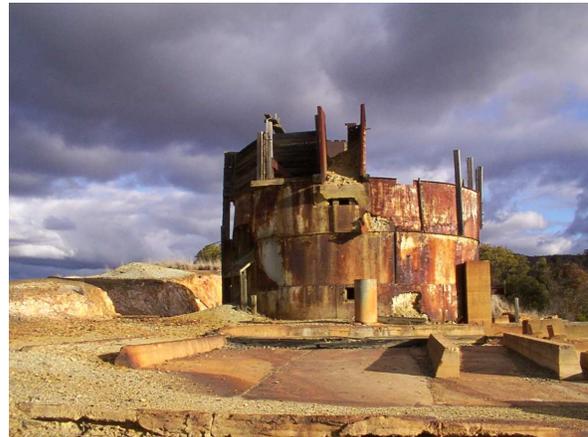
Figure 1. Old infrastructure at Captains Flat.

The Ngarigu Aborigines occupied the region prior to white occupation [Walkabout, no date]. Currently, relics from the old settlement and some remains of the old mine infrastructure still exist, as seen in Figure 1. Mounds of mine sludge dumps and tailings deposits are still structurally visible, as seen in Figure 2. Old architectures such as the hotel, and some old mine housing still exist in the village.

There is a growing community commitment and involvement in rehabilitating and preserving the history of Captains Flat site. The old infrastructure and mound hills of old tailings and capped sludge dumps are worth preserving for history and study purposes. However, there are reports of water contamination from leached heavy metals in Molonglo River and Lake Burley Griffin from this site. According to McGown (pers. communication, July, 2004), the infrastructure of this site is very well preserved and needs to be protected for its heritage value. Careful protection planning around the old infrastructure should preserve them for a period of time.

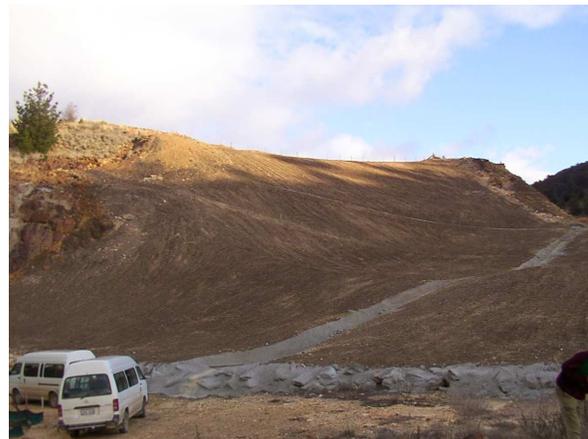
Figure 2. Sludge mound at Captains Flat mine site.

Previous failure of the tailings dam structure means a future rehabilitation plan should include monitoring of ground seepage and regular structural assessment around the existing tailings dams during and after rehabilitation processes. Revegetation around the mine site should be done as a major part of the rehabilitation process.

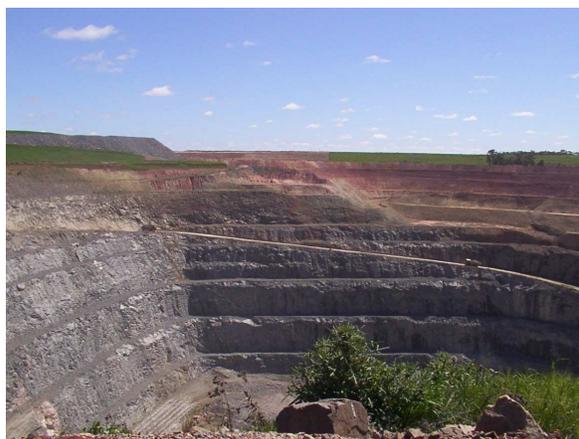
Northparkes Mine is currently operating, and is a combination of open pit and underground mining, as seen in Figure 3 and 4. There are large waste rock piles and tailings dams around the mine site, as seen in Figure 5. The tailings dam wall structures are relatively high compared to the ground surface, and are subject to future build up processes as required.

Figure 3. Northparkes open cut mine operation.

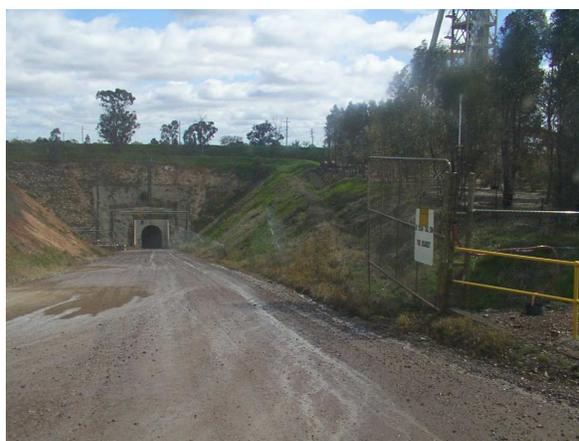
Figure 4. Underground mining operation at Northparkes.

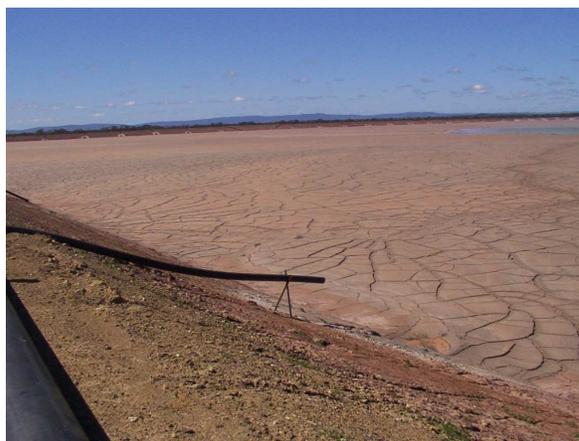
Figure 5. One of Northparkes tailings dams.

The risk of seepage of contaminated water from the tailings dam is very high for every mine operation and particularly at the Northparkes Mine. In order to minimise this risk, good management and active monitoring processes, such as the installation of piezometers around the risk areas, has already been implemented.

Northparkes Mine staff told us that sound rehabilitation processes are currently implemented for this mine site. They also claim that where possible, the in-fill soils that they use are of the same soil type that they removed, resulting in restoration of the soil condition. Re-vegetation projects seem to be part of their mine site operations, therefore, if this practice is continued, future rehabilitation will be straight forward and cost effective, although long term stabilisation of the additional build up of tailings dam wall structures will be potentially difficult.
